Cultural Resource Survey Program Series No. 3

**Cultural Resources Site Examination Report
of the Deansboro Creamery Co. Site,
Town of Marshall, Oneida County, New York**

Prepared for and sponsored by:
New York State Department of Transportation
And Federal Highway Administration

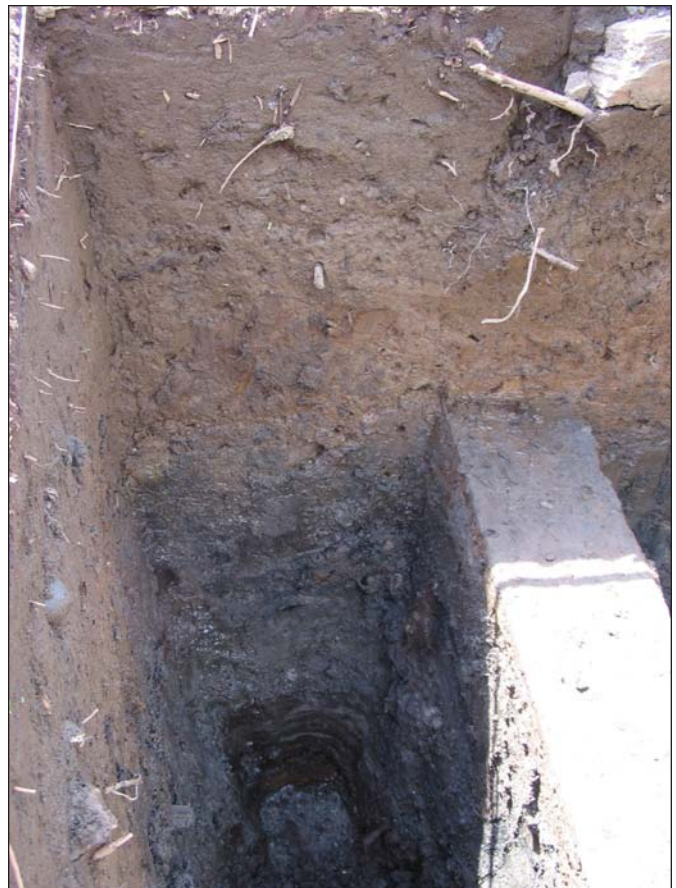
Photo 2. Test Unit 11 West Profile.

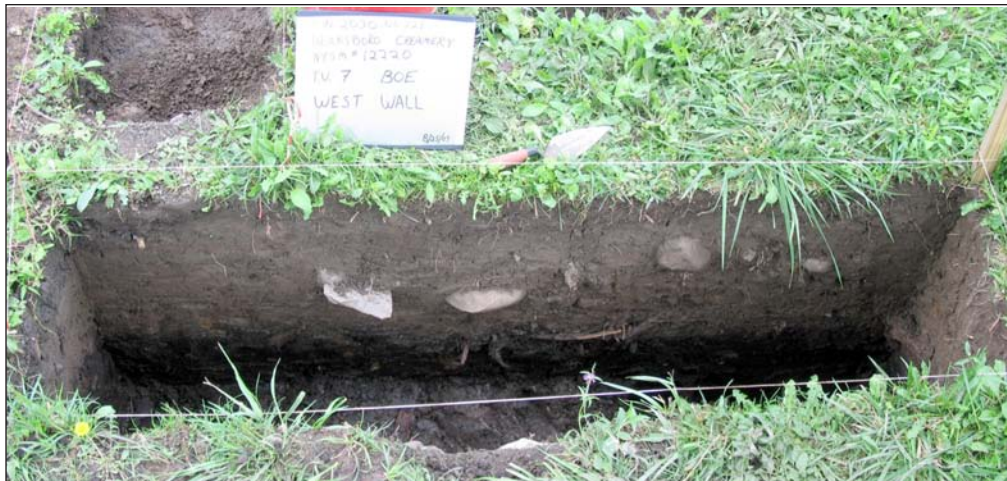
Photo 3. Test Unit 7 West Profile.

northwestern corner of the envelope as exposed in TU 7 (Figures 16 and 19, Photo 3). This mottled level is restricted to the building envelope and represents a remarkably clean construction fill deposit. Other than a few artifacts observed in a pipeline trench extending beneath the decomposing wood, artifacts are generally very sparsely distributed in the upper half of this stratum with a relative concentration near the upper boundary. As will be described in the feature section, sub foundation rounded cobbles were observed vertically stacked in TUs 1, 5, and 9 and Trench 12 suggesting the cobbles were placed in holes dug into this fill. These cobbles often rested on or compressed into the decomposing wood. Capping the site is a 20-45 cm (8-18 in) thick very dark grey brown to very dark brown silty loam which contains the majority of the cultural materials at the site. This level was revealed in some locations as a single massive soil layer with only minor gradational shifts. Here, excavation levels were arbitrary. In other parts of the site, excavators discerned a definite contact or boundary and broke this capping layer into two natural excavation levels. As detailed in the artifact analysis section, the vast majority of modern artifacts such as plastics are limited to the upper natural or arbitrary level suggesting minimal downward mixing into the second level over the last 50 years. The vertical distribution of melted glass (assumed related to the 1891 fire) shows a relatively small amount of melted glass in the upper portions of the construction fill (5%), the greatest amounts in the second level (56%), with

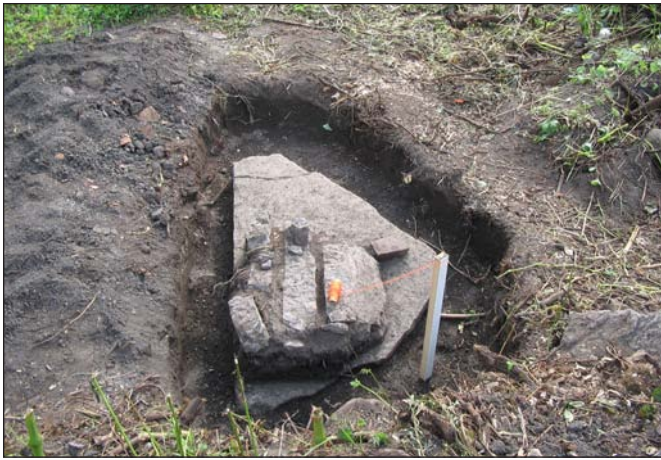
Photo 6. Looking East at Pier 1 (Feature 1 of Phase I Report).

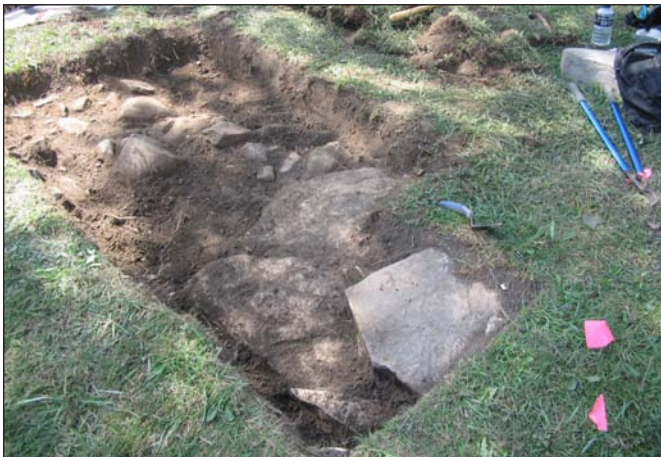
Photo 7. Looking Southwest at Pier 2.

Pier 2 supported the northeast corner of the factory (Figure 23, Photo 7). Exposed by Trench 13 and by probes, the intact pier measures .80 x 1.5 m (2.6 x 4.9 ft) and is at least two dry laid courses in height. The upper course was a large, flat, and smooth rock at an elevation of 0 cm. The second course consisted of massive blocks.

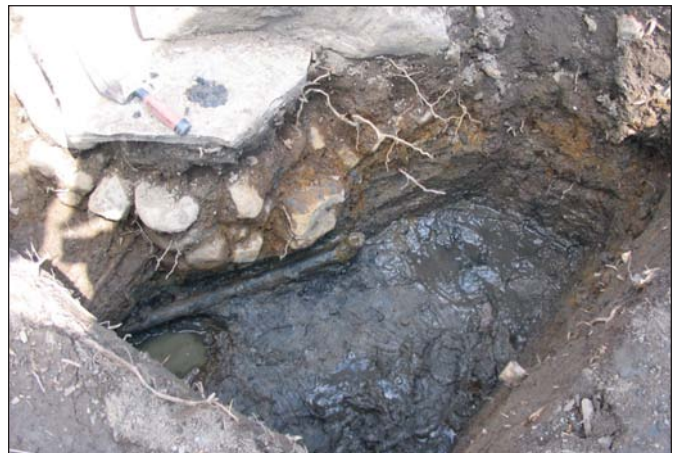
Photo 9. Looking Northeast at Pier 4 and the water line in Trench 12.

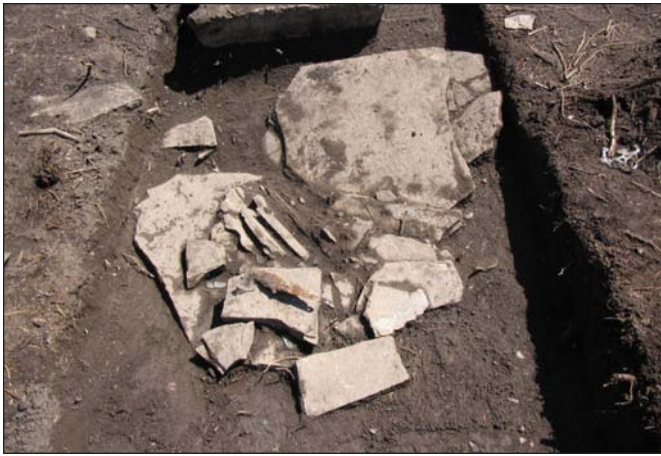
Photo 10. Looking East at Pier 5.

Pier 5 is located in the southeast corner of the factory building and was exposed by Trench 6 (Figure 23). This pier has been disturbed with the larger, upper two or more courses having been pushed and flipped over in a southeasterly direction (Photo 10). A large unassociated concrete block was at the ground surface immediately east of this pier. Excluding the overturned upper courses, the cluster of tabular stones is contained within an area of 1 x 1 m (3.3 x 3.3 ft) and lies at an elevation of 28 to 35 cm (11-14 in) below site datum. No mortar was noted and window glass, a bottle base, and a hinge were noted wedged between slabs of rock. Sediments beneath the exposed rock were not probed to verify the presence of rounded cobbles.

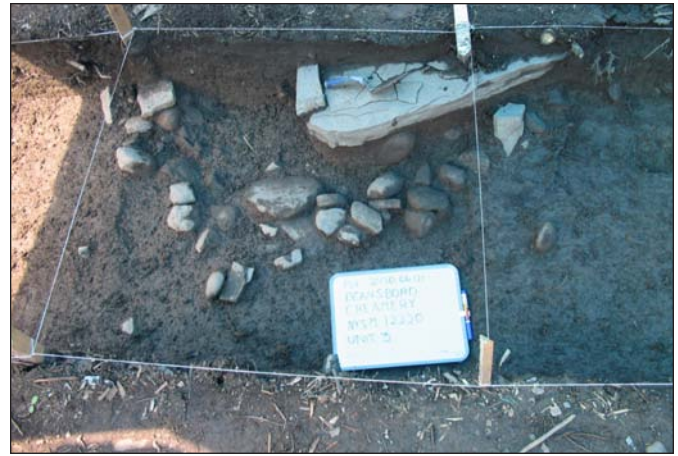
Photo 11. Looking West at Pier 6 in Test Units 2-4.

Pier 6 appears to have been slightly disturbed with the upper flat stone moved northward (Figures 23 and 25, Photo 11). This single slab measured approximately 50 x 80 cm (20 x 31 in) with the long axis paralleling the building with the top at 25 cm (10 in) below site datum. The sub foundation of cobbles included a single white-washed rock. The sub foundation had been placed in a larger, 1.7 m maximum dimension, basin shaped pit

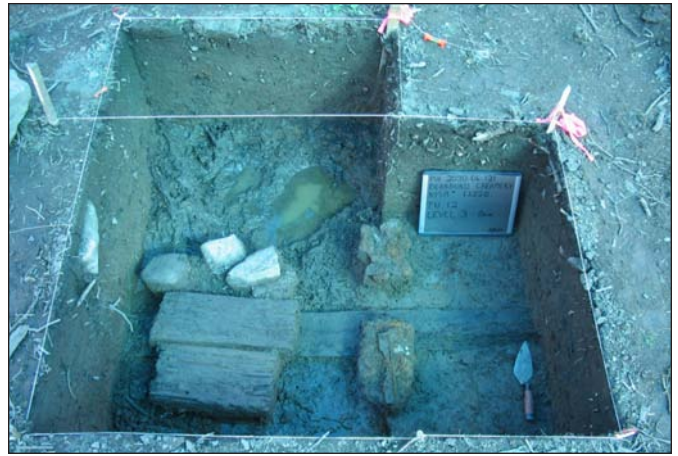
Photo 14. Pier 8 showing plank segments and cobbles.

Located approximately 9 feet (2.7 m) west of Pier 4, Pier 8 is uniquely constructed and was exposed in TUs 6, 11, and 12. The previously noted 7 x 1 3/16 in (18 x 3 cm) plank with a triangular cross-sectioned strip lies centrally at 62 cm (24 in) (Photo 13). This possible construction reference marker had a 5 cm (2 in) thick layer of soil over it and was then covered by one of two short lengths of thick board (Photo 14). The segment directly above the plank measured 8 x 19 x 2 1/2-3/4 in (20 x 48 x 6.3 cm) and the board to the south measured 8 x 16 x 2 1/2 in (20 x 41 x 6.3 cm). A single fragment of glass

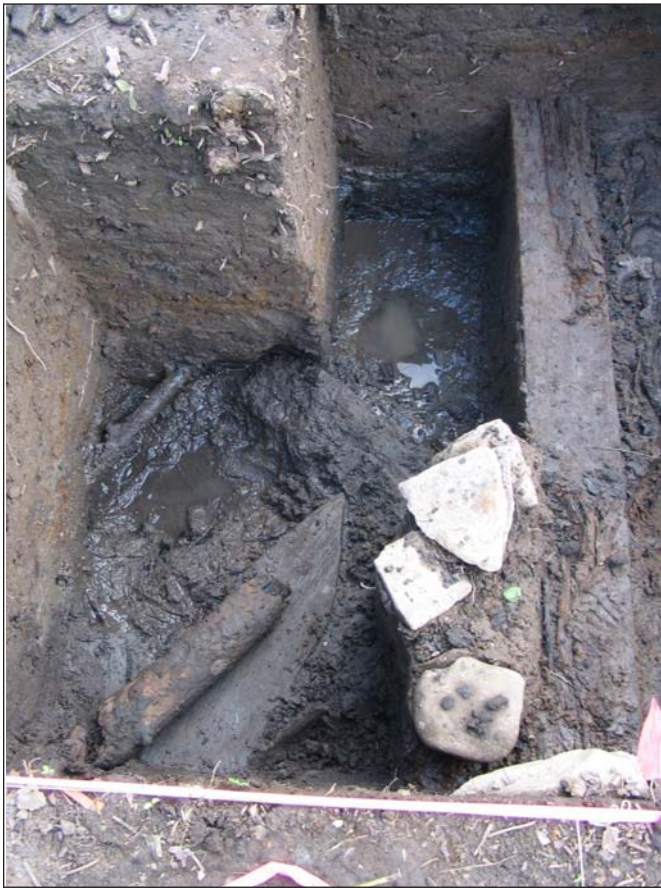
Photo 13. Plan View of base of Pier 8 with east at top of page.

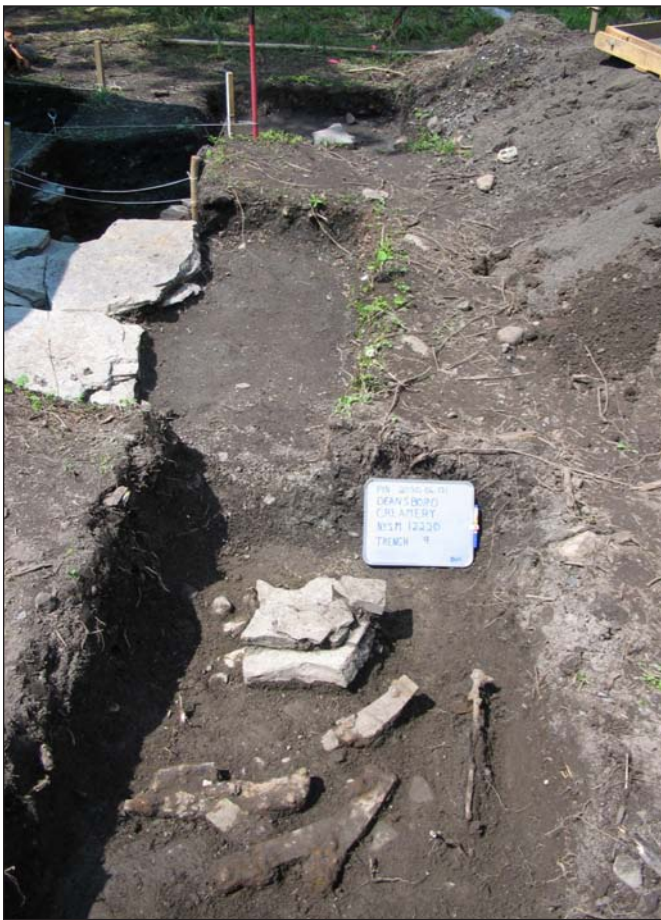
Photo 16. Looking north across Pier 11 to Pier 10 with boiler platform to the left.

A 10 x 14 ft (3 x 4.3 m) shed protruded from the east wall of the factory (Figure 23). Its outline is defined by two small piers (Photo 16), Piers 10 and 11, and the masonry ledge on the east side of Pier 3. The structure sheltered a boiler as evidenced by a substantial masonry platform, burned soils, and a large volume of coal, coal ash, and slag. The piers both had upper elevations of 18 cm (7 in) below site datum and the ledge on Pier 3 was 25 cm (9.8 in) below datum suggesting a slightly sloped floor. Assuming the boiler shed had a floor and had similar sized sill beams to those in the factory, the boiler shed would have had a lower floor with the step up to the main factory floor of 7-9.8 in (18-25 cm). That step would have been greater if the shed sills and joists were less substantial. The boiler platform was at 8 or 9 cm (3-3.5 in) below datum. For fire safety reasons, one might assume this platform would be level with or raised above any decking in the shed rather than being recessed in the floor. Therefore, if the shed had a wood-

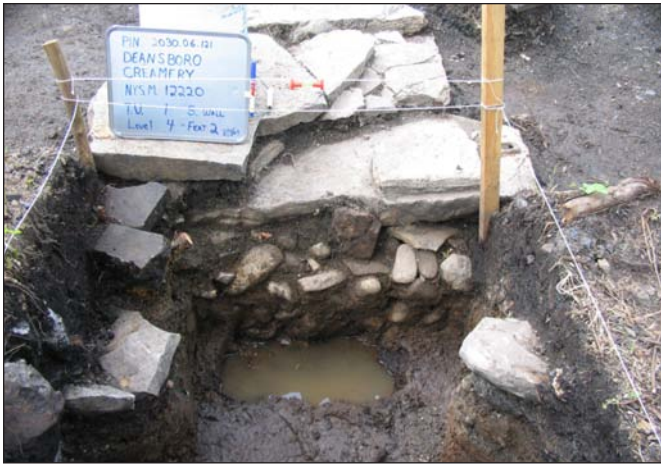
Photo 17. Boiler Platform and Test Unit 1 South Wall Profile.

The boiler platform was first observed during Phase 1 and designated Feature 2 in that report. At that time, it was not known if this was a floor or an exterior stoop or doorway. STP 28.6 found the buried flat multi-stone platform and further probing defined a roughly square area measuring 150 x 150 cm (5 x 5 ft). STPs 28.6 and 28.7 were placed at what was thought to be opposite corners. The testing found two layers of unmortared flat stone masonry, 18 cm (7 in) thick underlain by a stack of irregular cobbles. The lower cobbles were placed on sterile grey clay with a mottled brown and ashy grey clay loam flanking the lower portions of the feature and charcoal blackened sandy loam with coal and coal ash level with and capping the slab. STP 28.7 found a similar large flat slab at 20 cm (8 in) but this part of the feature rested upon a 30 cm (12 in) thick bed of well-sorted, small (fist-sized or smaller) cobbles. These rested on light brown to grey clay. At that time, it was felt the smaller cobble fill seems to function less for support and more for drainage. Although these observations were found mostly corroborated by Phase 2 testing, Trench 2 and TU 1 exposed greater details about the construct (Figure 23). The platform consists of a 4 x 8 ft (2.4 x 4.8 m) rectangular area of flat slabs in two to three courses to a depth of approximately 40 cm (16 in) placed upon a large bed of rounded cobbles to a depth of 65 cm (26 in) (Photo 17). The cobbles had been placed in a nearly vertically sided pit dug into the construction fill

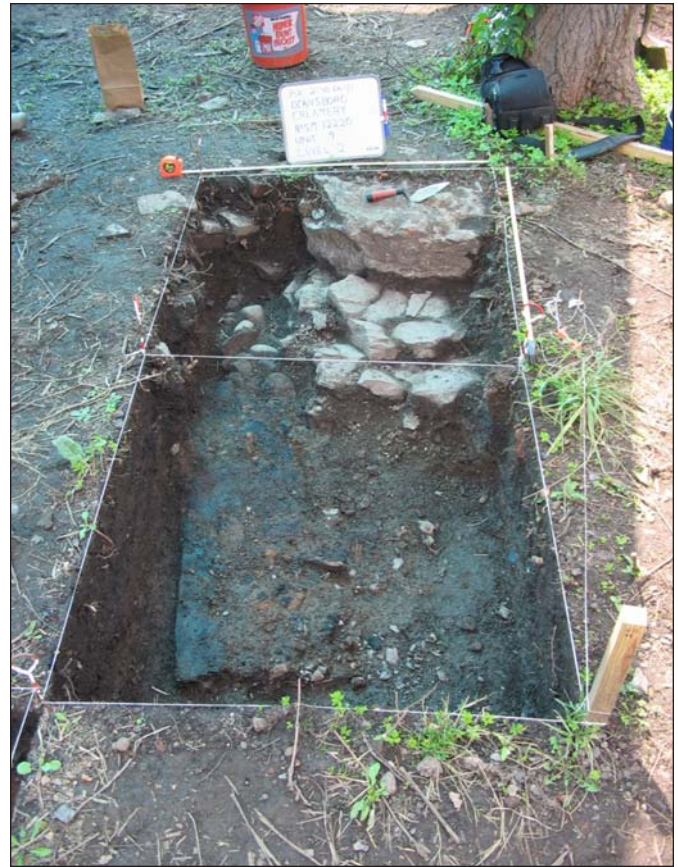
Photo 18. Burned lumber panel and Pier 3.

The only concentration of burned wood was found in TUs 5 and 9 at approximately 50 cm (20 in) resting just above the top of the construction fill and tilting down slightly to the north (Photo 18). This location approxi-

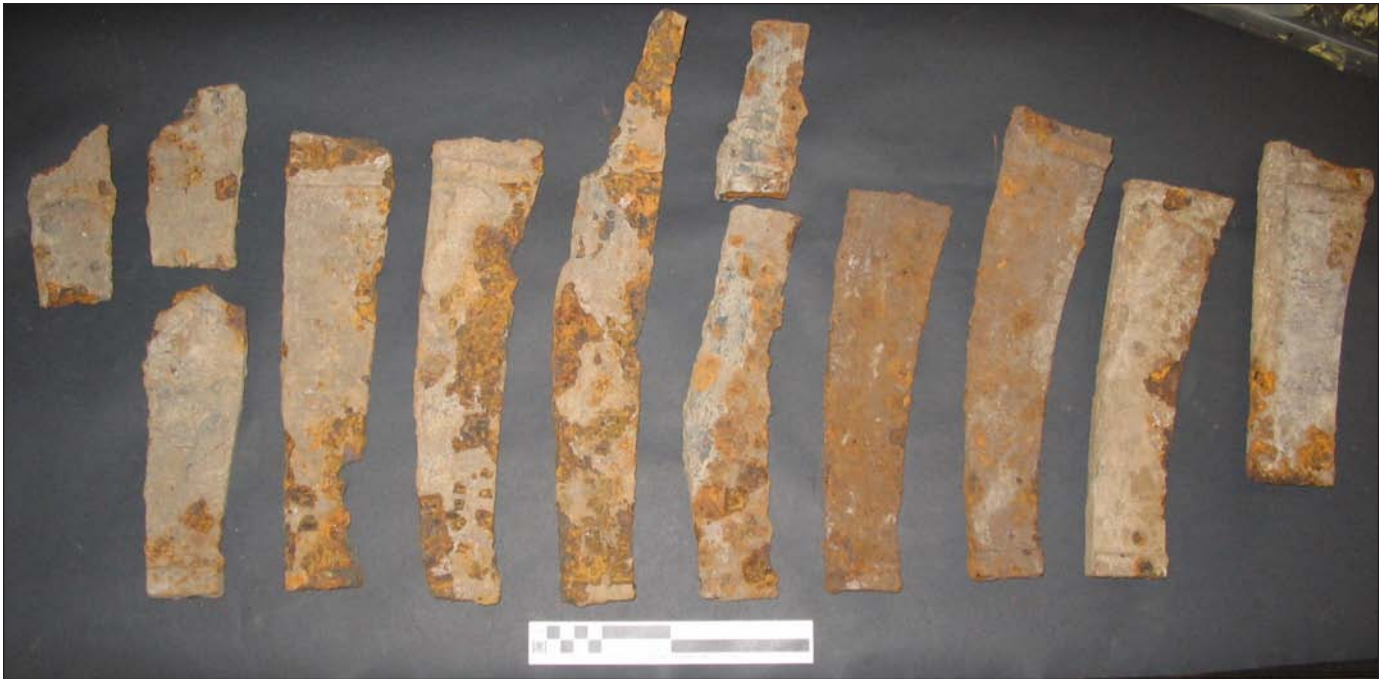
Photo 28. Boiler Grate Fins.
