Cultural Resources Site Examination Report

**J. G. BYARS
SITE**

NY ROUTE 22 OVER THE WALLOOMSAC RIVER
TOWN OF NORTH HOOSICK
RENSSELAER COUNTY, NEW YORK

**Cultural Resources Site Examination Report
of the J. G. Byars Site (NYSM # 11370)
NY Route 22 Over the Walloomsac River
Town of North Hoosick
Rensselaer County, New York**

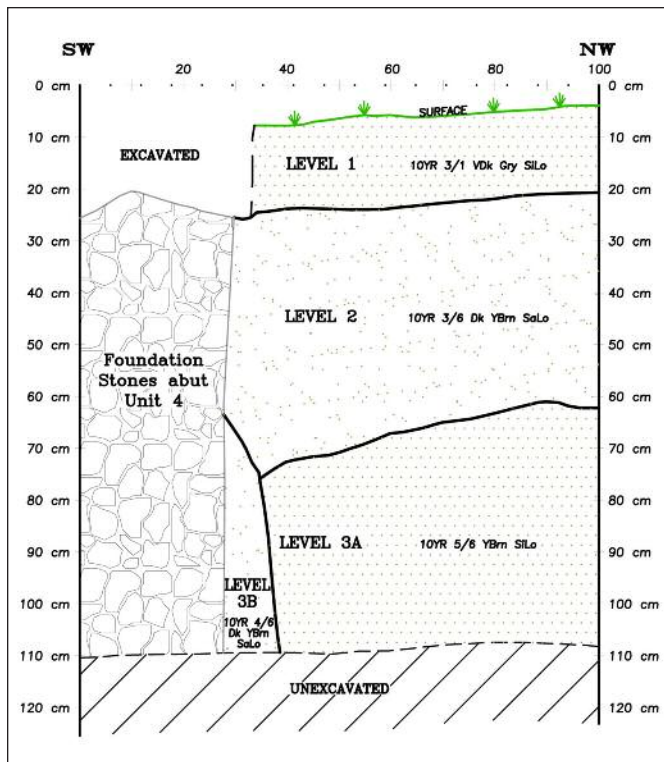
Figure 15. Unit 4 west wall profile.

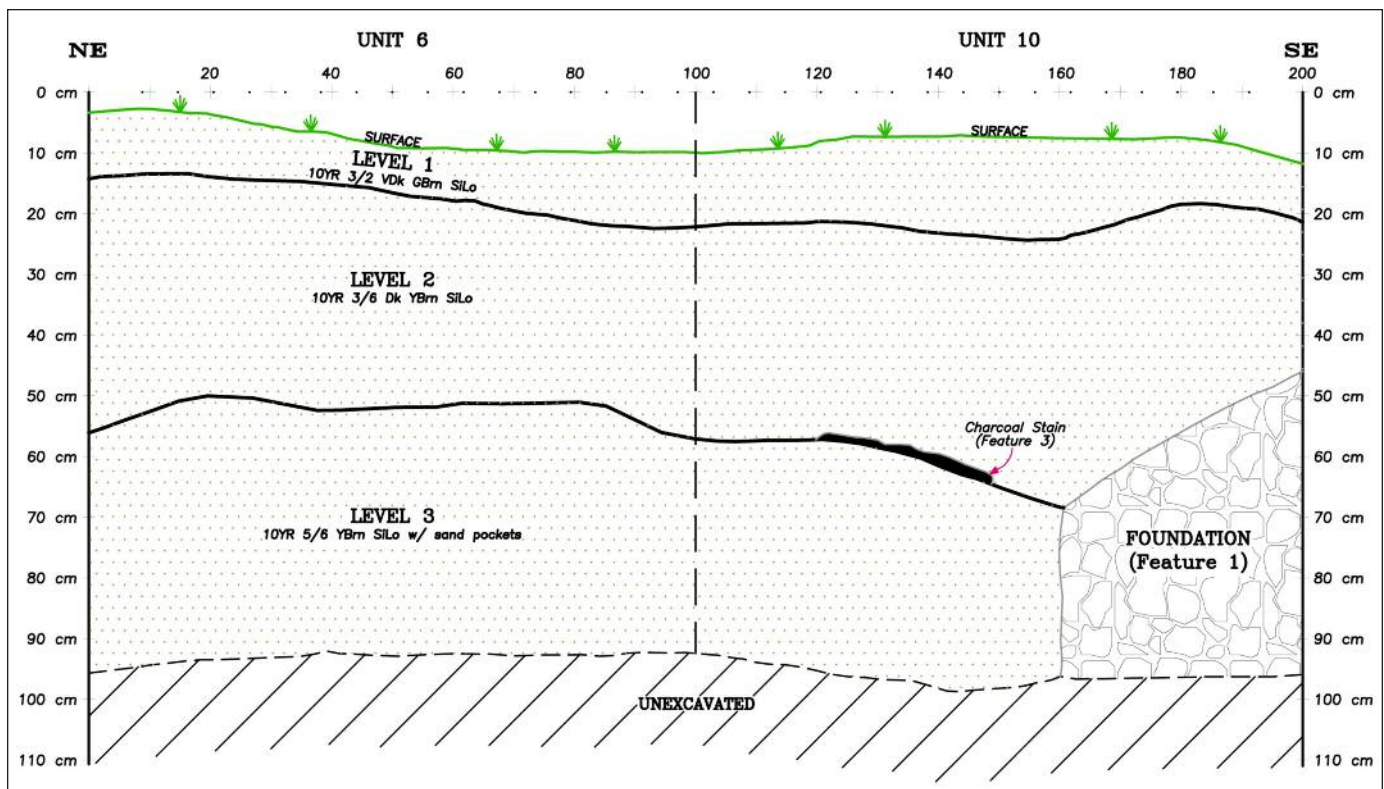
Figure 16. Units 6 and 10 combined east wall profile.

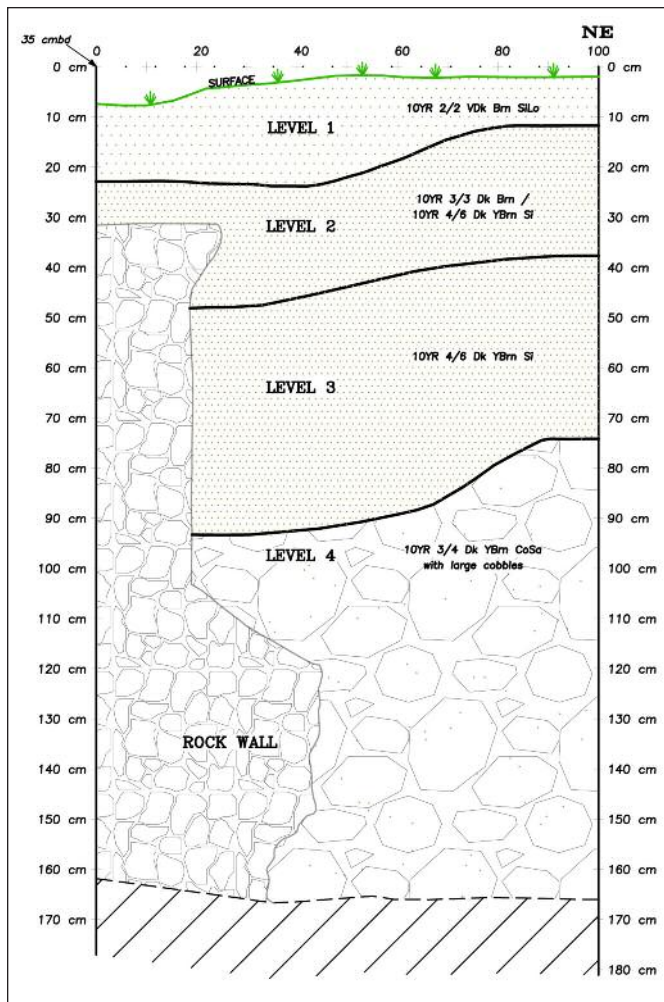
Figure 17. Unit 8 north wall profile.

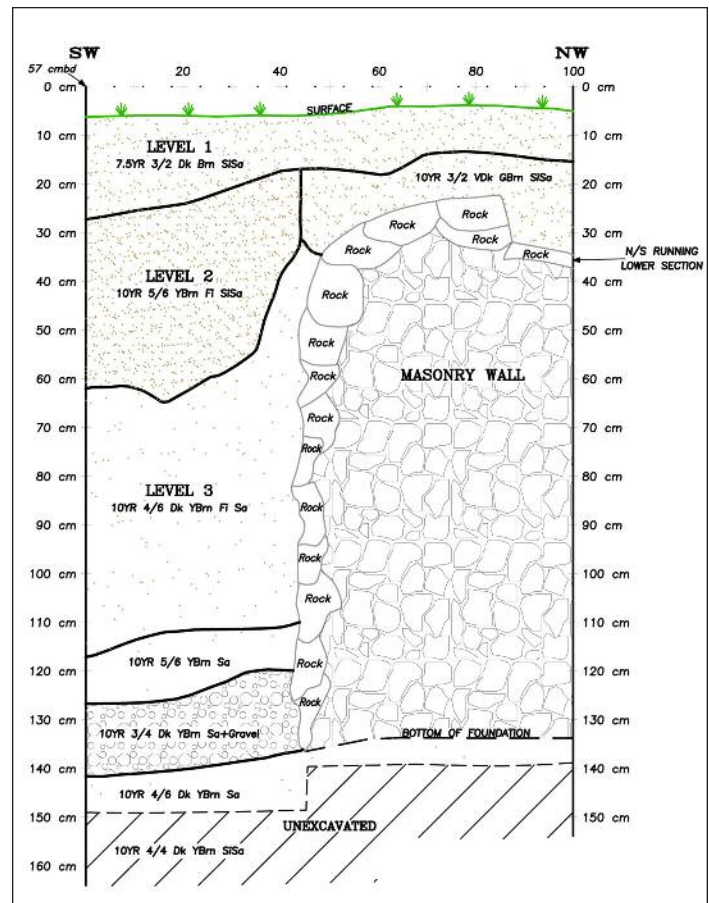
Figure 18. Trench 1 west wall profile.

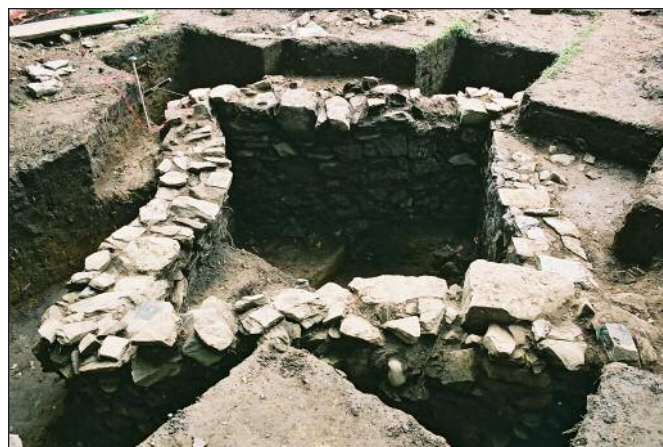
Photo 5. J. G. Byars Site foundation after nearly all deposits inside were excavated. View facing southeast.

The external dimensions of the foundation measured 3 m (9.8 ft) square, and the walls measured approximately 50 to 65 cm (20 to 26 in) thick (see Figure 14; Photo 5). The east wall was bowed in by some likely post-demise

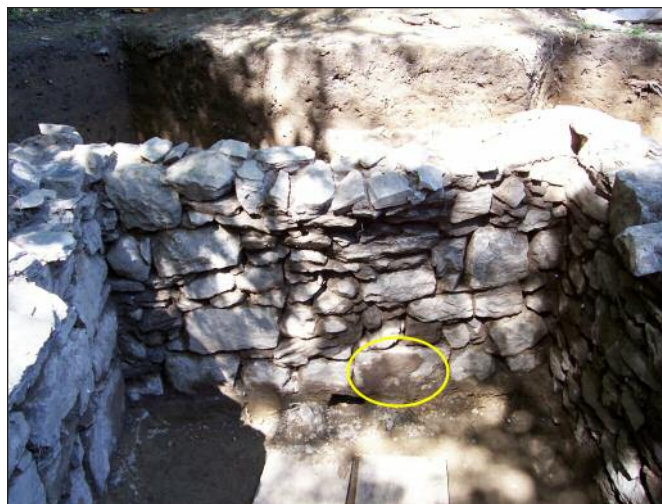
Photo 6. Interior east wall of foundation with plaster area highlighted.

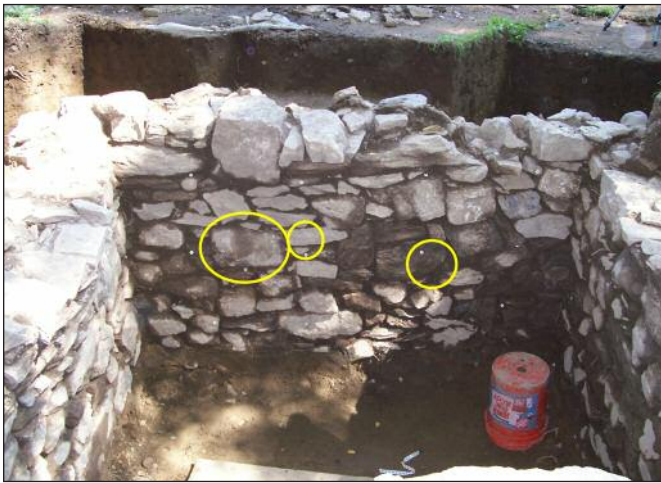
Photo 8. Interior south wall of foundation with plaster areas highlighted.

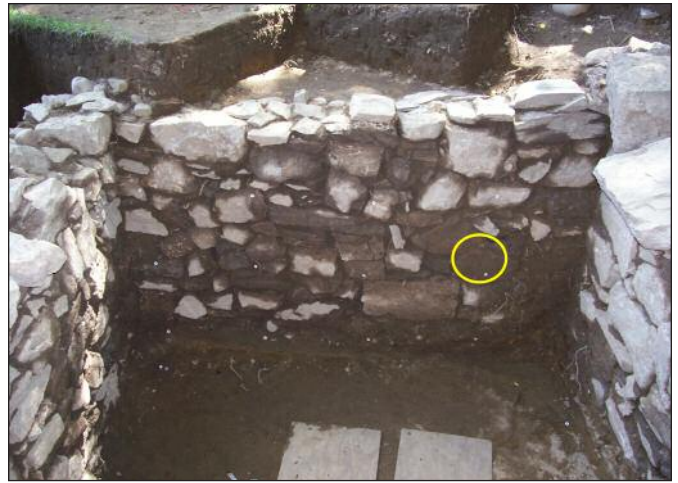
Photo 11. Interior west wall of foundation with plaster highlighted.

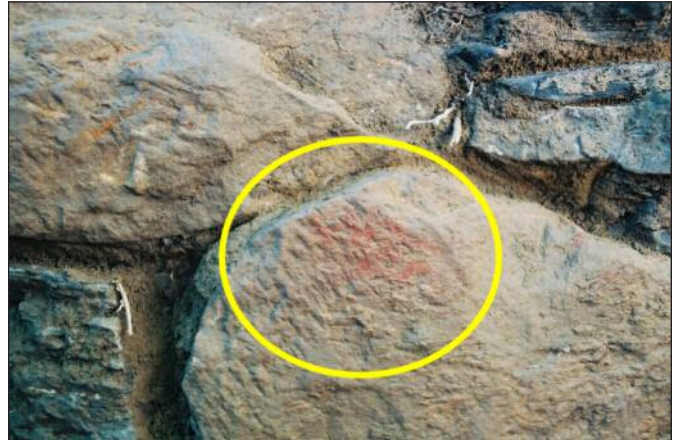
Photo 12. Close-up of plaster location on west wall of foundation. Note the reddish color, possibly paint.

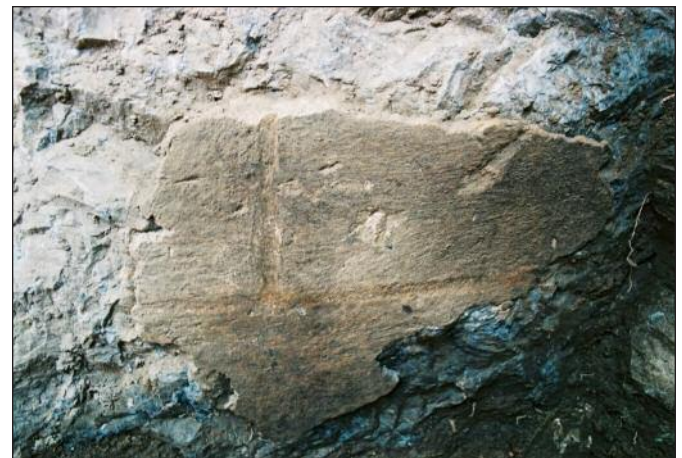
Photo 16. Close-up of lower right plaster location on north wall of foundation. Note the rectangular pattern of incised lines on the surface.

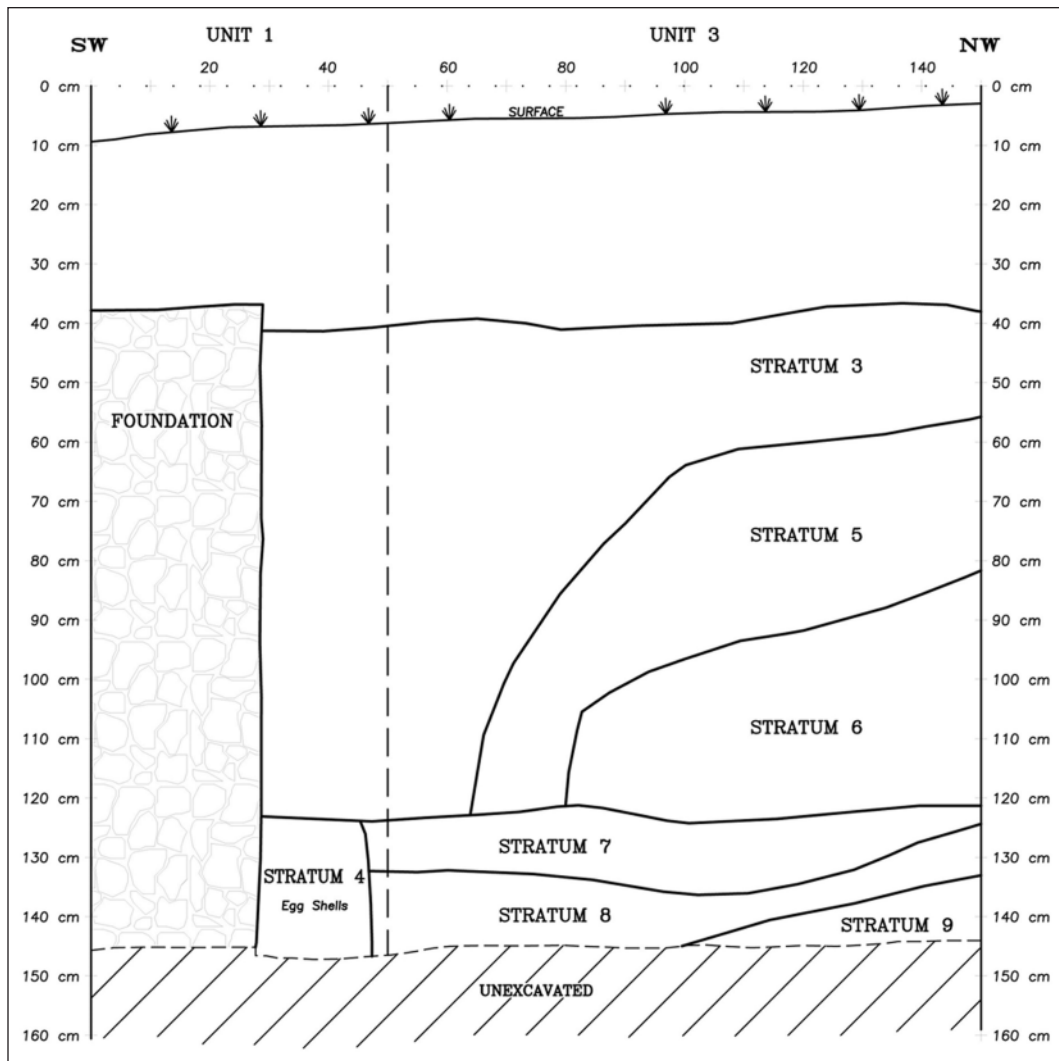
Figure 22. Profile of west walls of Units 1 and 3 inside the foundation.

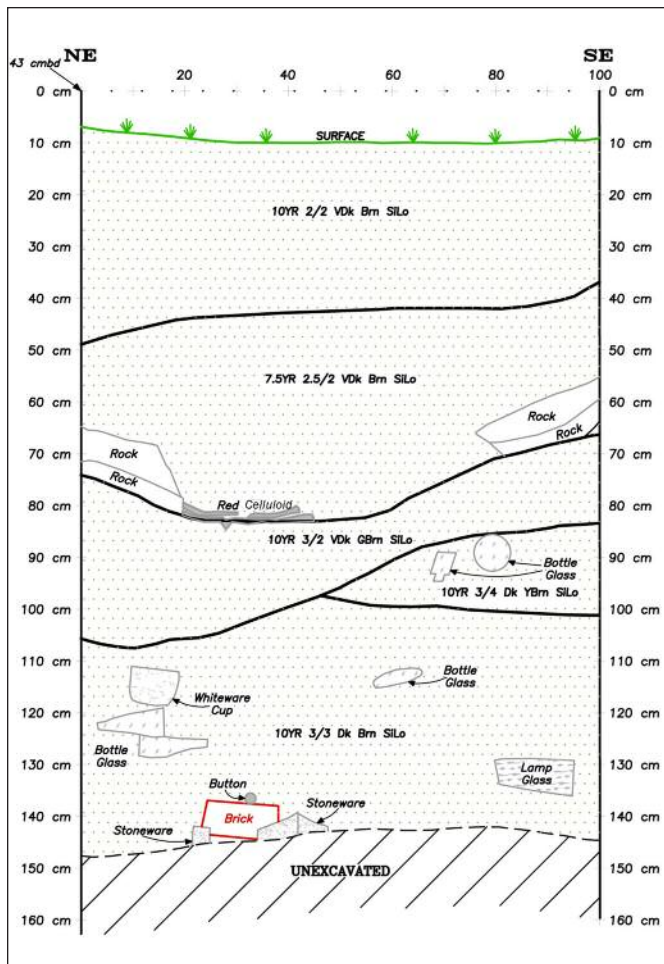
Figure 23. Profile of the east wall of Unit 3 inside the foundation.
